Original Paper

Lion Mountain Landslide in Non-urbanized Terrain: Changing the Myth of Landslide Occurrence in Western Sierra Leone

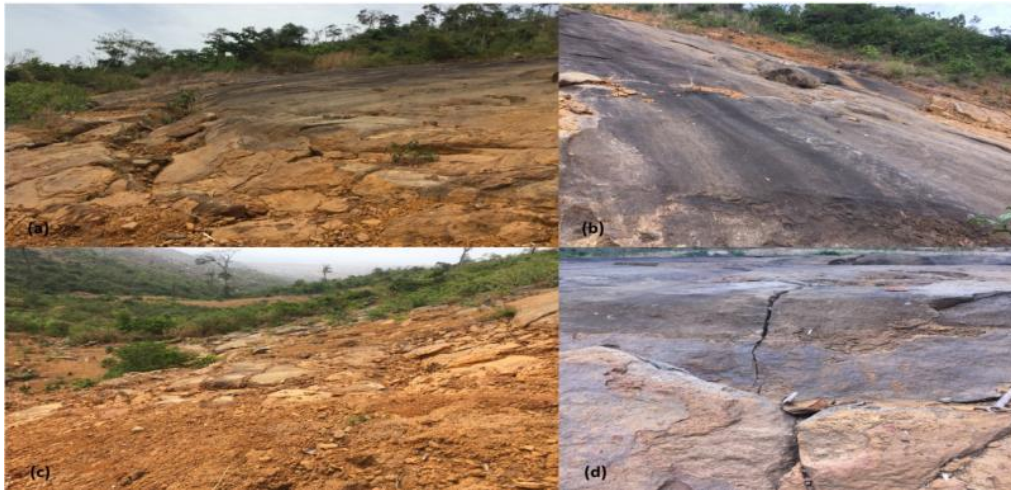
Also, the orientation of rock layering (ESE-WNW) and dip (43° NW-almost the same as sliding plane) at the landslide site when compared with the strike and dip of outcrops on adjacent slopes and the mountain village (8.430708N, 13.243174W) showed correspondence. This aided in distinguishing in-situ rocks from boulders. The boulders with diameters ranging from 2m to 5.5m, were deposited at the bottom slope and along the stream valley underneath. They range from rounded old black surface colour weathered corestones to angular chunks released from the fractured rock mass.

Figure 4. Local Geology (a) Distinct Zones along Slope Face Showing Differential Weathering, Separated by a Transverse Crack, (b) Typical Rock Type with Evidence of Exfoliation Joints, (c) Intensely Weathered Landslide Basal Section Where the Slippage/Failure may Have Initiated, (d) Parallel Proto-Joints in the Process of Developing as Full Mechanical Fractures but Maintaining Considerable True Cohesion

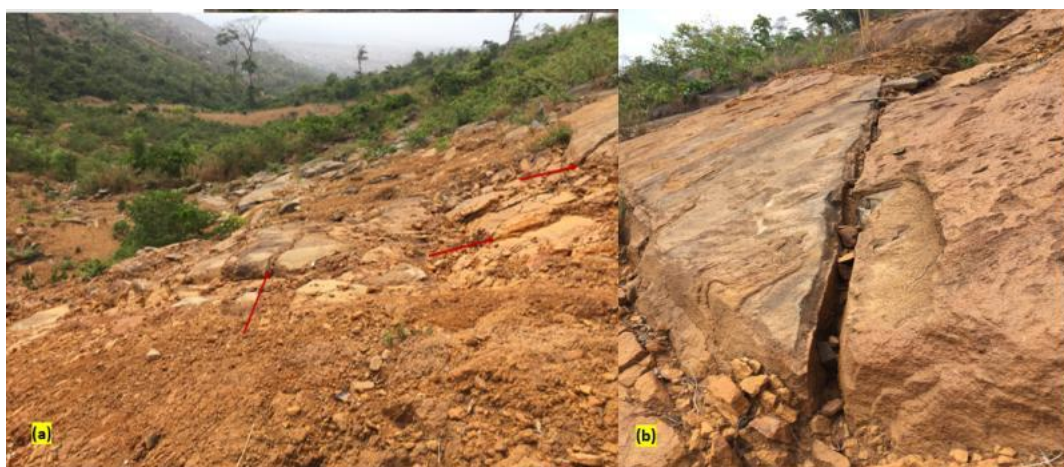
The constituent rock is susceptible to chemical weathering, with clearly weathered zones at the ridge top (weathering profile is estimated as 2.6 m thick) and very thin along the flanks (1.5m-2.5m). Rocks at the upper landslide base are strongly affected by weathering (block weathering/rind weathering) (Figure 5a), and is seemed concentrating in the fractured planes/zones, which together with upward groundwater flow and increased pore-pressure on key joints may have initiated basal failure.

Figure 5. (a) Joint Sets (Vertical Dip) in Highly Weathered Pegmatitic Gabbro, (b) The Largest Offset Fracture (15mm) within the Landslide Area

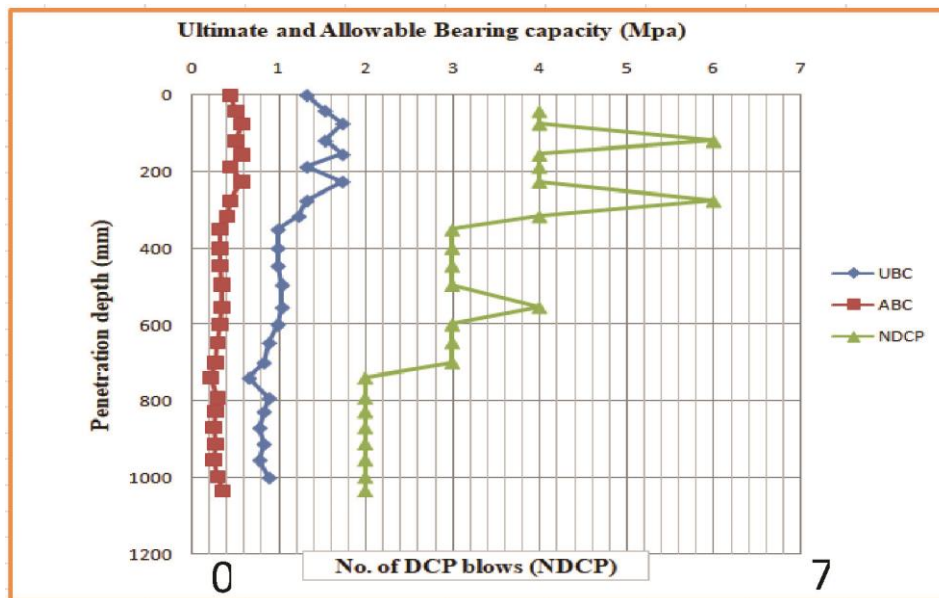
The DCP probed or revealed information on the thickness of weathered soil cover (depth > 1.5m) and its bearing strength. The strength factor, which according to UNDP & EPA (2017) was not considered by the affected populations at Regent prior construction in supposedly a non built-up areas. However, results of DCP tests presented in Figure 8 show variation in soil bearing strength with depth along the soil profile, which generally decrease towards the bed rock. The average number of DCP blows (NDCP) plot also varies with depth and shows strong correlation with the weak to moderate gabbroic layering. This method evaluated the susceptibility of the bottom soil layer that slipped down the slope and extrapolated the potetial effects of overloading (e.g., precipitation/rainfall, infrastructures, sediment piling and dam) on landslide occurrence (i.e., implied anthropogenic impacts).

Figure 8. Variation of Average Bearing Strength Capacity and NDCP in the Soil Profile Overlying the Bed Rock. UBA: Ultimate Bearing Capacity, ABC: Allowable Bearing Capacity and NDCP. Number of DCP Blows

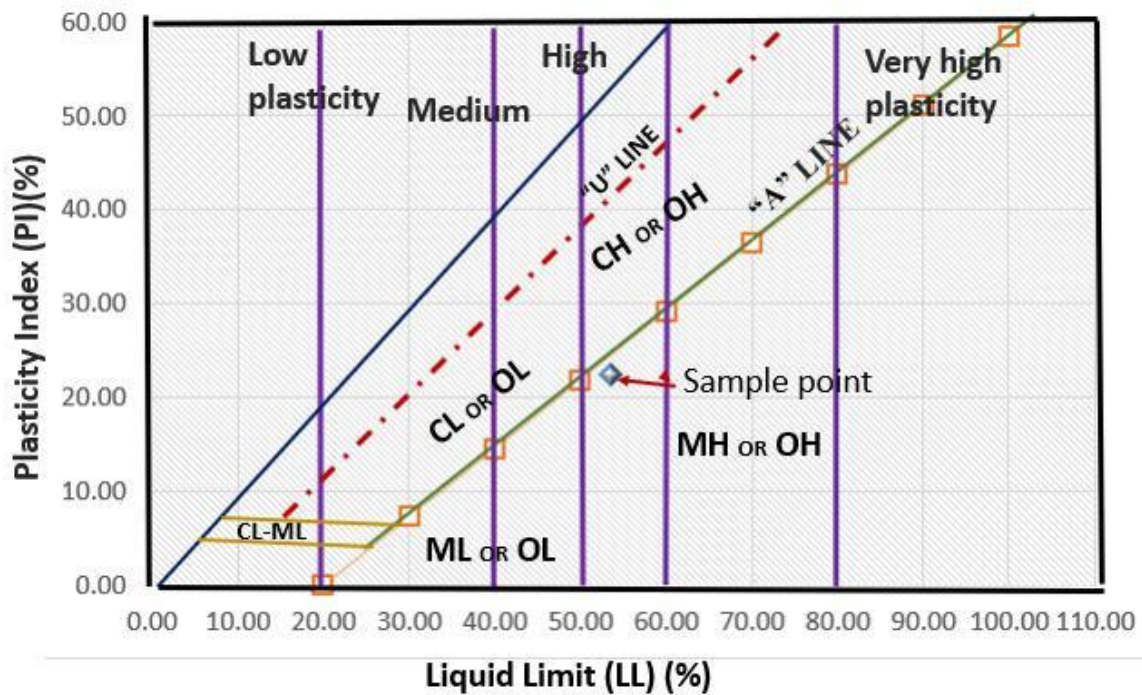
The second part of the geotechnical assessment involves the determination of natural moisture content, specific gravity (G), grain size distributions consistency limits (Plastic Limit, Liquid Limit and Plasticity Index), and Liquidity Index (LI) of the landslide soil. Results of these parameters are presented in Table 1. The soil moisture content is within range, average specific gravity estimated as 2.41, which is below the specific gravity of the fresh rock sample (2.8). The soil is well-graded, which have been grouped into three divisions corresponding to the major constituents. They include: gravel, sand and fines (clay and silt), with the fines exceeding the gravel component. The fine fraction can affect permeability and enhance pore pressure following periods of persistent rainfall. With the absence of X-Ray Diffraction (XRD) facility in the country to identify and determine clay fraction, analysis at the British Geological Survey (BGS) laboratories in Nottingham on Regent bulk debris samples, presented by Redshaw et al. (2019), has given an insight into the probable clay mineral type called halloysite. This clay mineral is linked to collapsible soil, which Moon (2016) has mentioned as one that can yield very suddenly when rapidly loaded. As noted by EL Jazouli et al. (2020), plasticity is regarded as one of the important parameters in the properties of water retention and corresponding swelling. Therefore, larger plasticity correlates to greater volume change that could impact landslide susceptibility. The Unified Soil Classification System (USCS) plasticity chart enabled further classification of the representative soil sample as seen in Figure 9. The laboratory-derived atterberg limits (PI=22.37%, and LL=53.46) aided in distinguishing the fines by plotting the values in the plasticity chart. The sample location falls below the “A” line (a line which Casagrande empirically plotted in his devised plasticity chart in 1948, separating inorganic clays and silt and organic soils), indicating that the soil sample contains silts and clays with large constituent of ‘rock flour (finely ground non-clay minerals). The Liquidity Index (LI) or a measure of the consistency of the soil is negative (-0.24), signaling drier nature of the soil than the plastic limit. This is due to the lower moisture content (23.70%), which correlates strongly to the period during which sampling was done (dry season), relative elevation, aspect and fine content (silt).

Figure 9. Plasticity Chart of the Representative Soil Collected from Lion Mountain Landslide

Geotechnical investigation revealed the nature, characteristic and type of landslide soil cover. It is a well-graded soil with a percentage of fine fraction greater than gravels (see Table 1)-a characteristic contributing to landslide susceptibility. Laboratory-derived Atterberg limits have shown the soil to be plastic with high expansion potential ($LL=53.46$). The DCP tested the in-situ soil strength along the soil profile, with the two strength parameters (ultimate Bearing Capacity and Allowable Bearing Capacity) generally displaying reduction in their values towards the bedrock, indicating weaker layer at the bottom that is prone to failure. This variation indicates different zones/layers marked by varied modal percentages. The weaker zone indicates greater tendency to slope failure than hard layers.
